Priest Bridge Overlook (Site 41)

**UPPER PATUXENT RIVER WATERSHED RESTORATION ACTION STRATEGY (WRAS)
FORM 1 -- Catchment Information**

**UPPER PATUXENT RIVER WATERSHED RESTORATION ACTION STRATEGY (WRAS)
FORM 2 -- Site Information**

Site Name: Priest Bridge Overlook Address: MD450

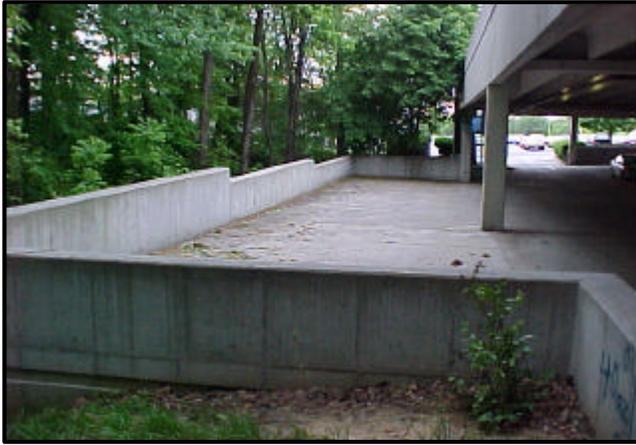
- No. 819 Description: looking west along south side of site
- No. 820 Description: looking north along east side of site
- No. 821 Description: looking west along north side of site
- No. 822 Description: looking south along east side of site
- No. 823 Description: looking south along west side of site
- No. 824 Description: looking east along north side of site
- No. 825 Description: looking north along west side of site
- No. 826 Description: looking east along south side of site
- No. 827 Description: looking northeast across lower level parking
- No. 828 Description: looking northeast across upper level parking

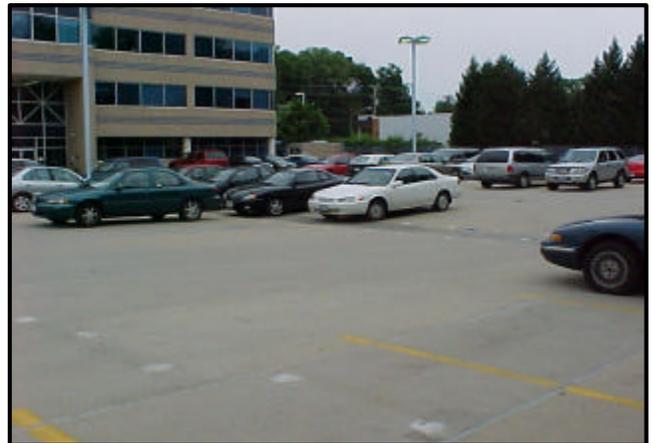
828

Comments Parking garage appears to be directed to storm drain system. Little opportunity in parking deck because drains exit structure high in lower level.

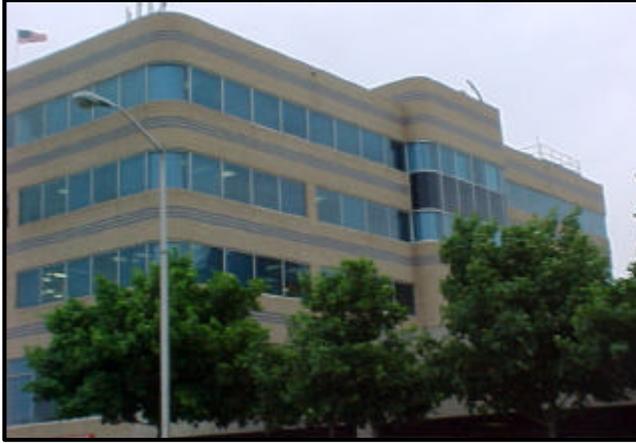
829

New LID IMP SWM BMP Retrofit New SWM BMP Type (Sheets 4 & 5): 7

Identify all Impairments Addressed by Recommendation (Sheet 1): 1, 4, 7, 16

Estimate IMP / BMP drainage area included on site: 0.28 ac 100%

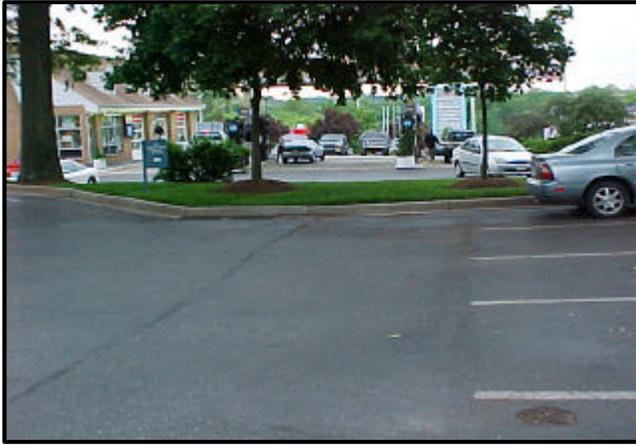
830

New LID IMP SWM BMP Retrofit New SWM BMP Type (Sheets 4 & 5): 39

Identify all Impairments Addressed by Recommendation (Sheet 1): 1, 2, 3, 4, 7, 16
